A34 Safety Review

Project Summary

September 2017

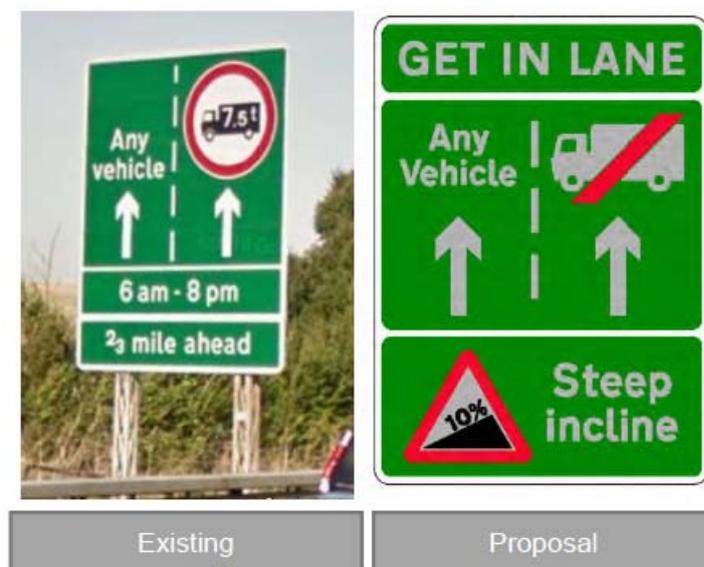
Figure 2 – Proposed signage at Gore Hill

'Rear end shunts' are thought to be caused by the steep uphill gradient at Gore Hill. Whilst monitoring has not been done on Heavy Goods Vehicles (HGVs) in lane 2, it is widely thought that the ban in lane 2 is ignored, increasing queuing and congestion upstream. The East Ilsley junction merge compromises the safe exit of vehicles as the entry point is on the approach on Gore Hill. CCTV surveys are recommended to better understand the HGV ban before any improvements are made.

2 – Improve signage at Gore Hill

- Reinstall previously removed signage and introduce supplementary sign 'slow lorries for 1 mile' which warns of the steep gradient at the junction of East Ilsley. This will provide clear reasoning for the HGV ban in lane 2 ahead for motorists.
- This intervention was also identified by the Thames Valley Police report in 2016, produced following fatal collisions in the area.
- Provide another sign in advance of the Gore Hill lane 2 ban indicating which vehicles can use the lane. It is considered that abuse of the existing lane 2 weight restriction is because the current sign is not fully understood.
- It is suggested that a unique sign, subject to approval by the DfT, could be used to better convey the lane 2 HGV ban.

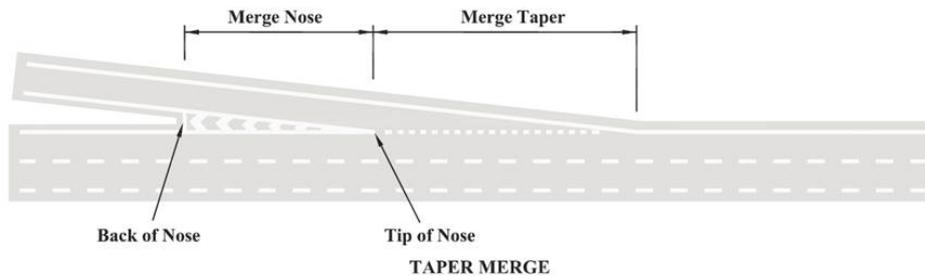
Figure 4 – Proposed junction layout

- The road is steeper than the recommended gradient for a dual carriageway
- Ashridge Farm Cottage has direct access to the A34 which is non-compliant with this type of road
- The junction merge at East Ilsley should be longer
- There is one lay-by in this area and it is the wrong type of lay-by for this road

4 - Improvements to the East Ilsley Junction

- The proposal is to reconfigure the junction arrangement to standardise the merge layout so that it is the correct length.
- Minimal carriageway widening would be required. This will allow vehicles to build up speed to match the speed of traffic on the A34.
