A34 Safety Review

Project Summary

September 2017

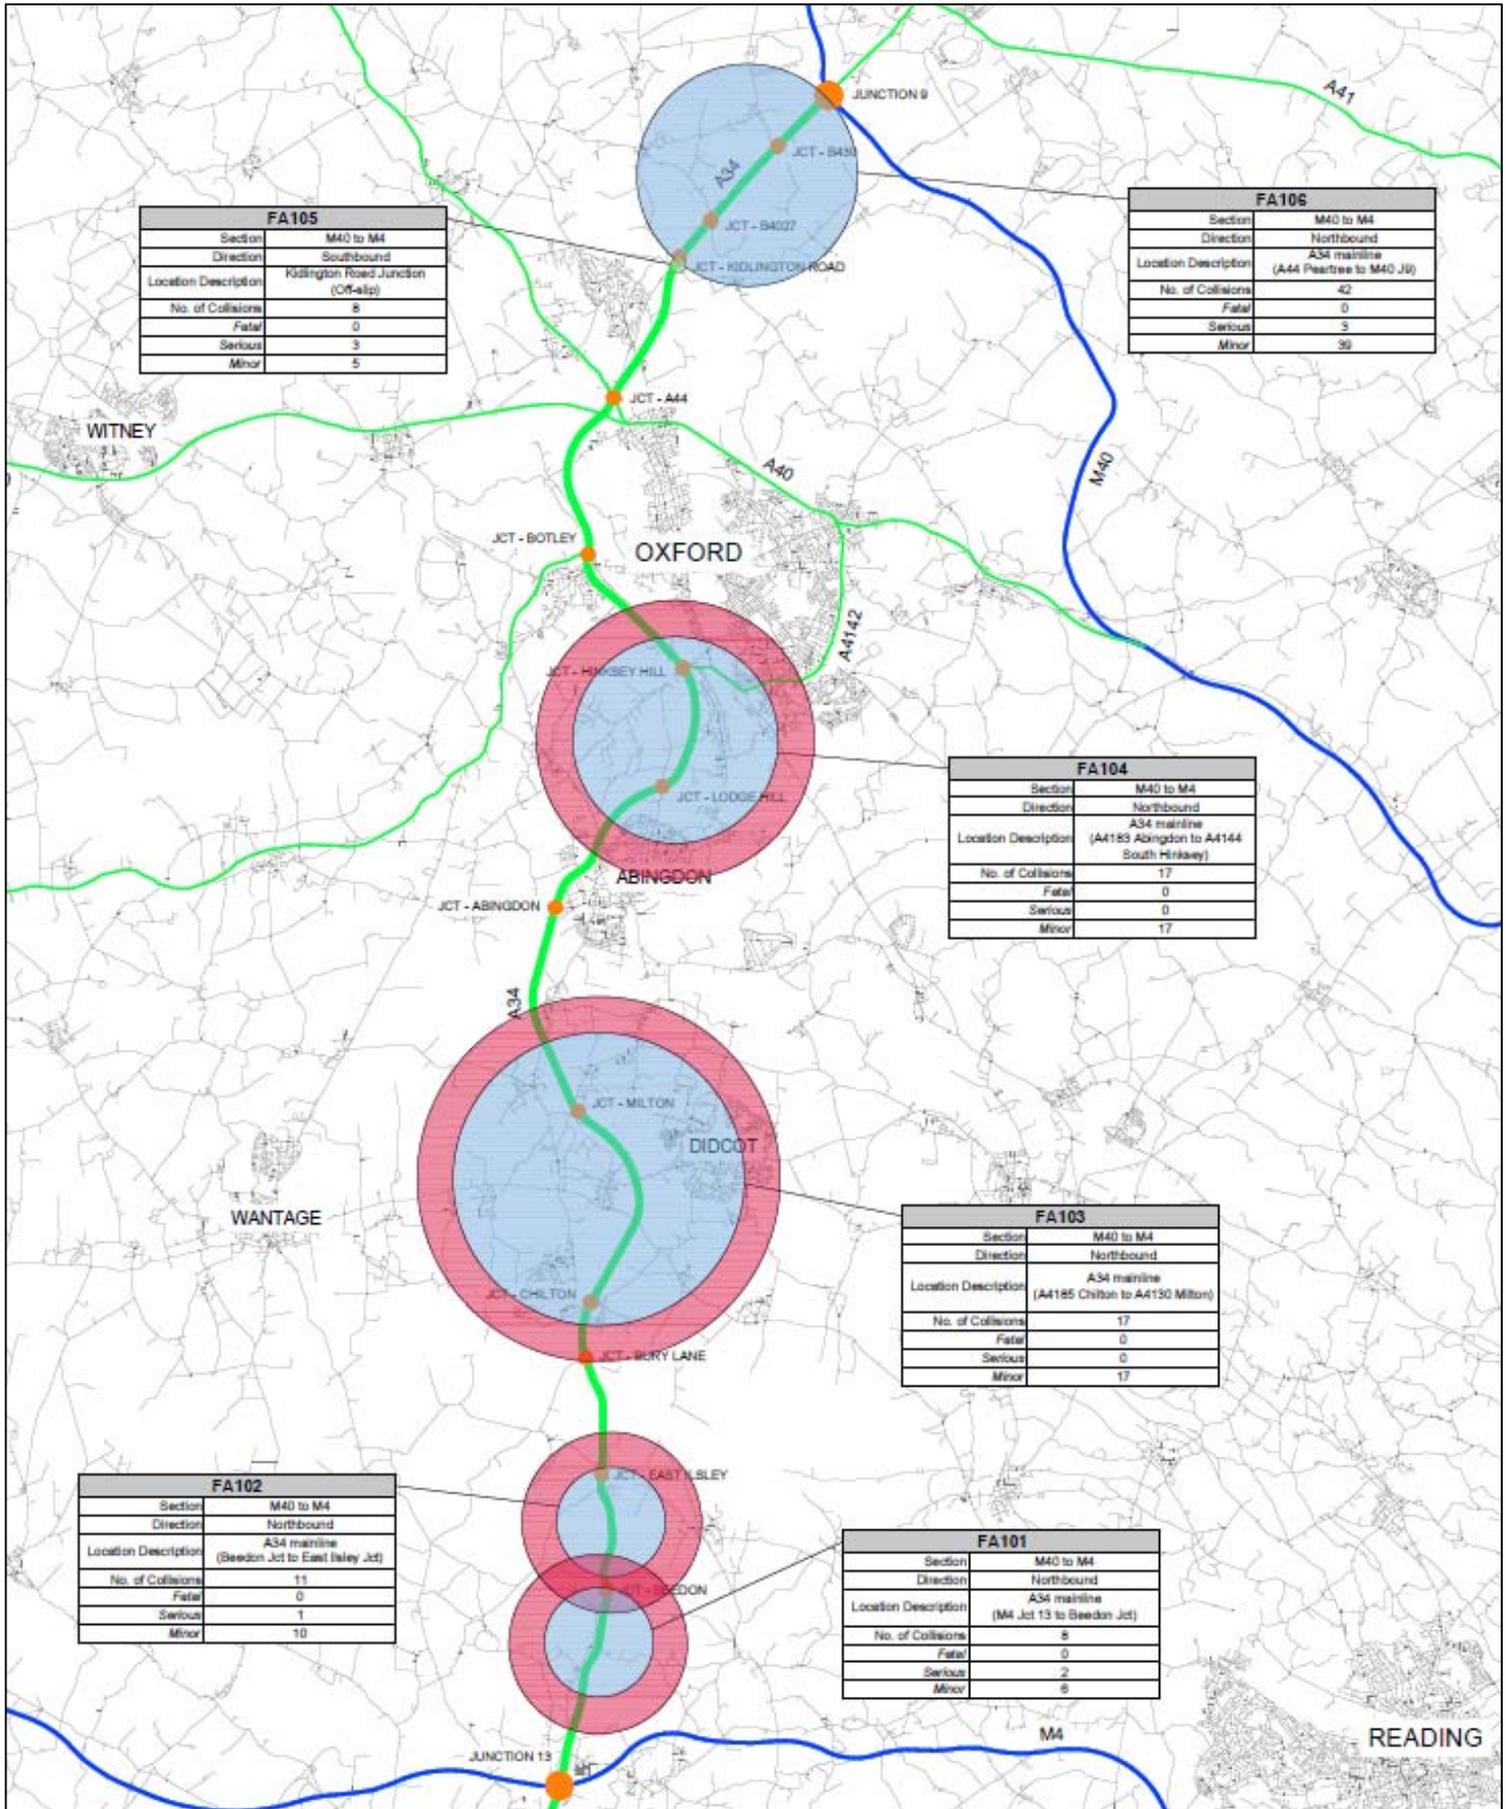
Figure 1 – Focus Areas

7 focus areas were identified in this section of the route. The Focus Area at M40 Junction 9 was not taken forwards as it has previously undergone improvement works. Six were taken forwards further in the review, to explore any relationships between cluster areas and carriageway compliance. The six Focus Areas, shown in Figure 1, will inform any recommendations for improvements to the A34. Five of the focus areas were identified on the northbound carriageway and one on the southbound carriageway at Kidlington junction.
